ABBOTT MEMORIAL TRUST DAM

N H 00260

**PHASE I INSPECTION REPORT
NATIONAL DAM INSPECTION PROGRAM**

APRIL 1979

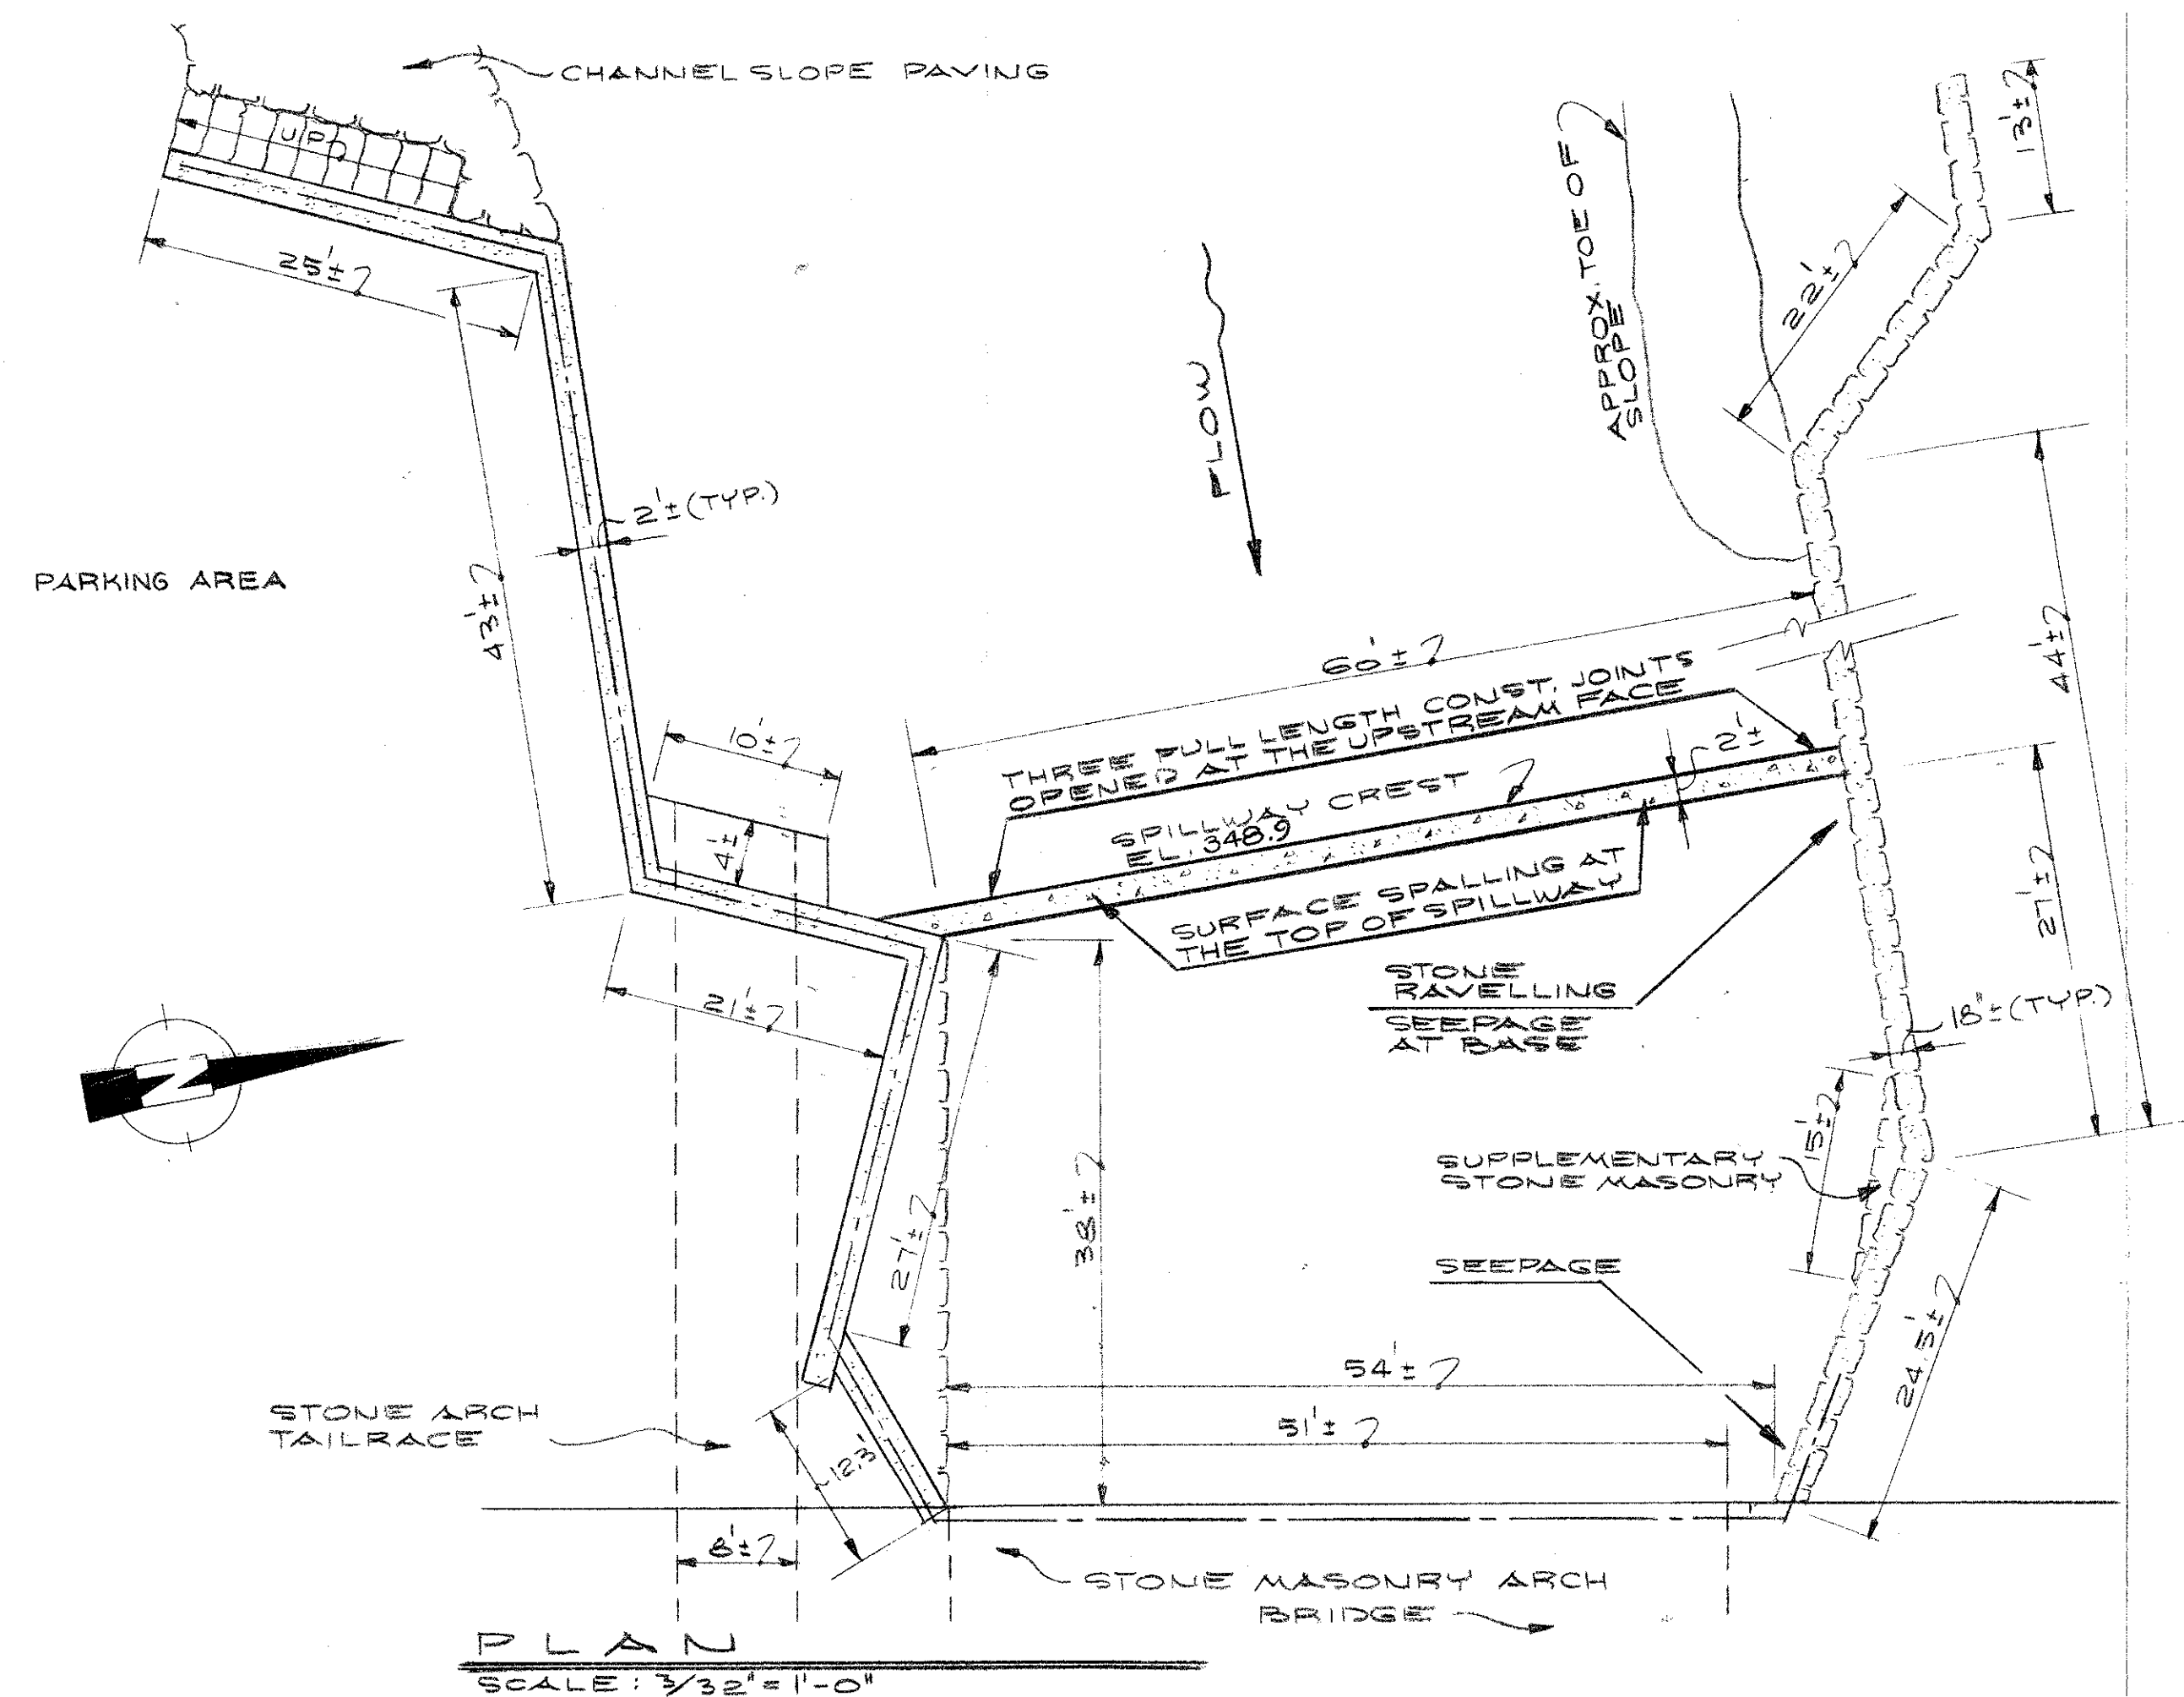
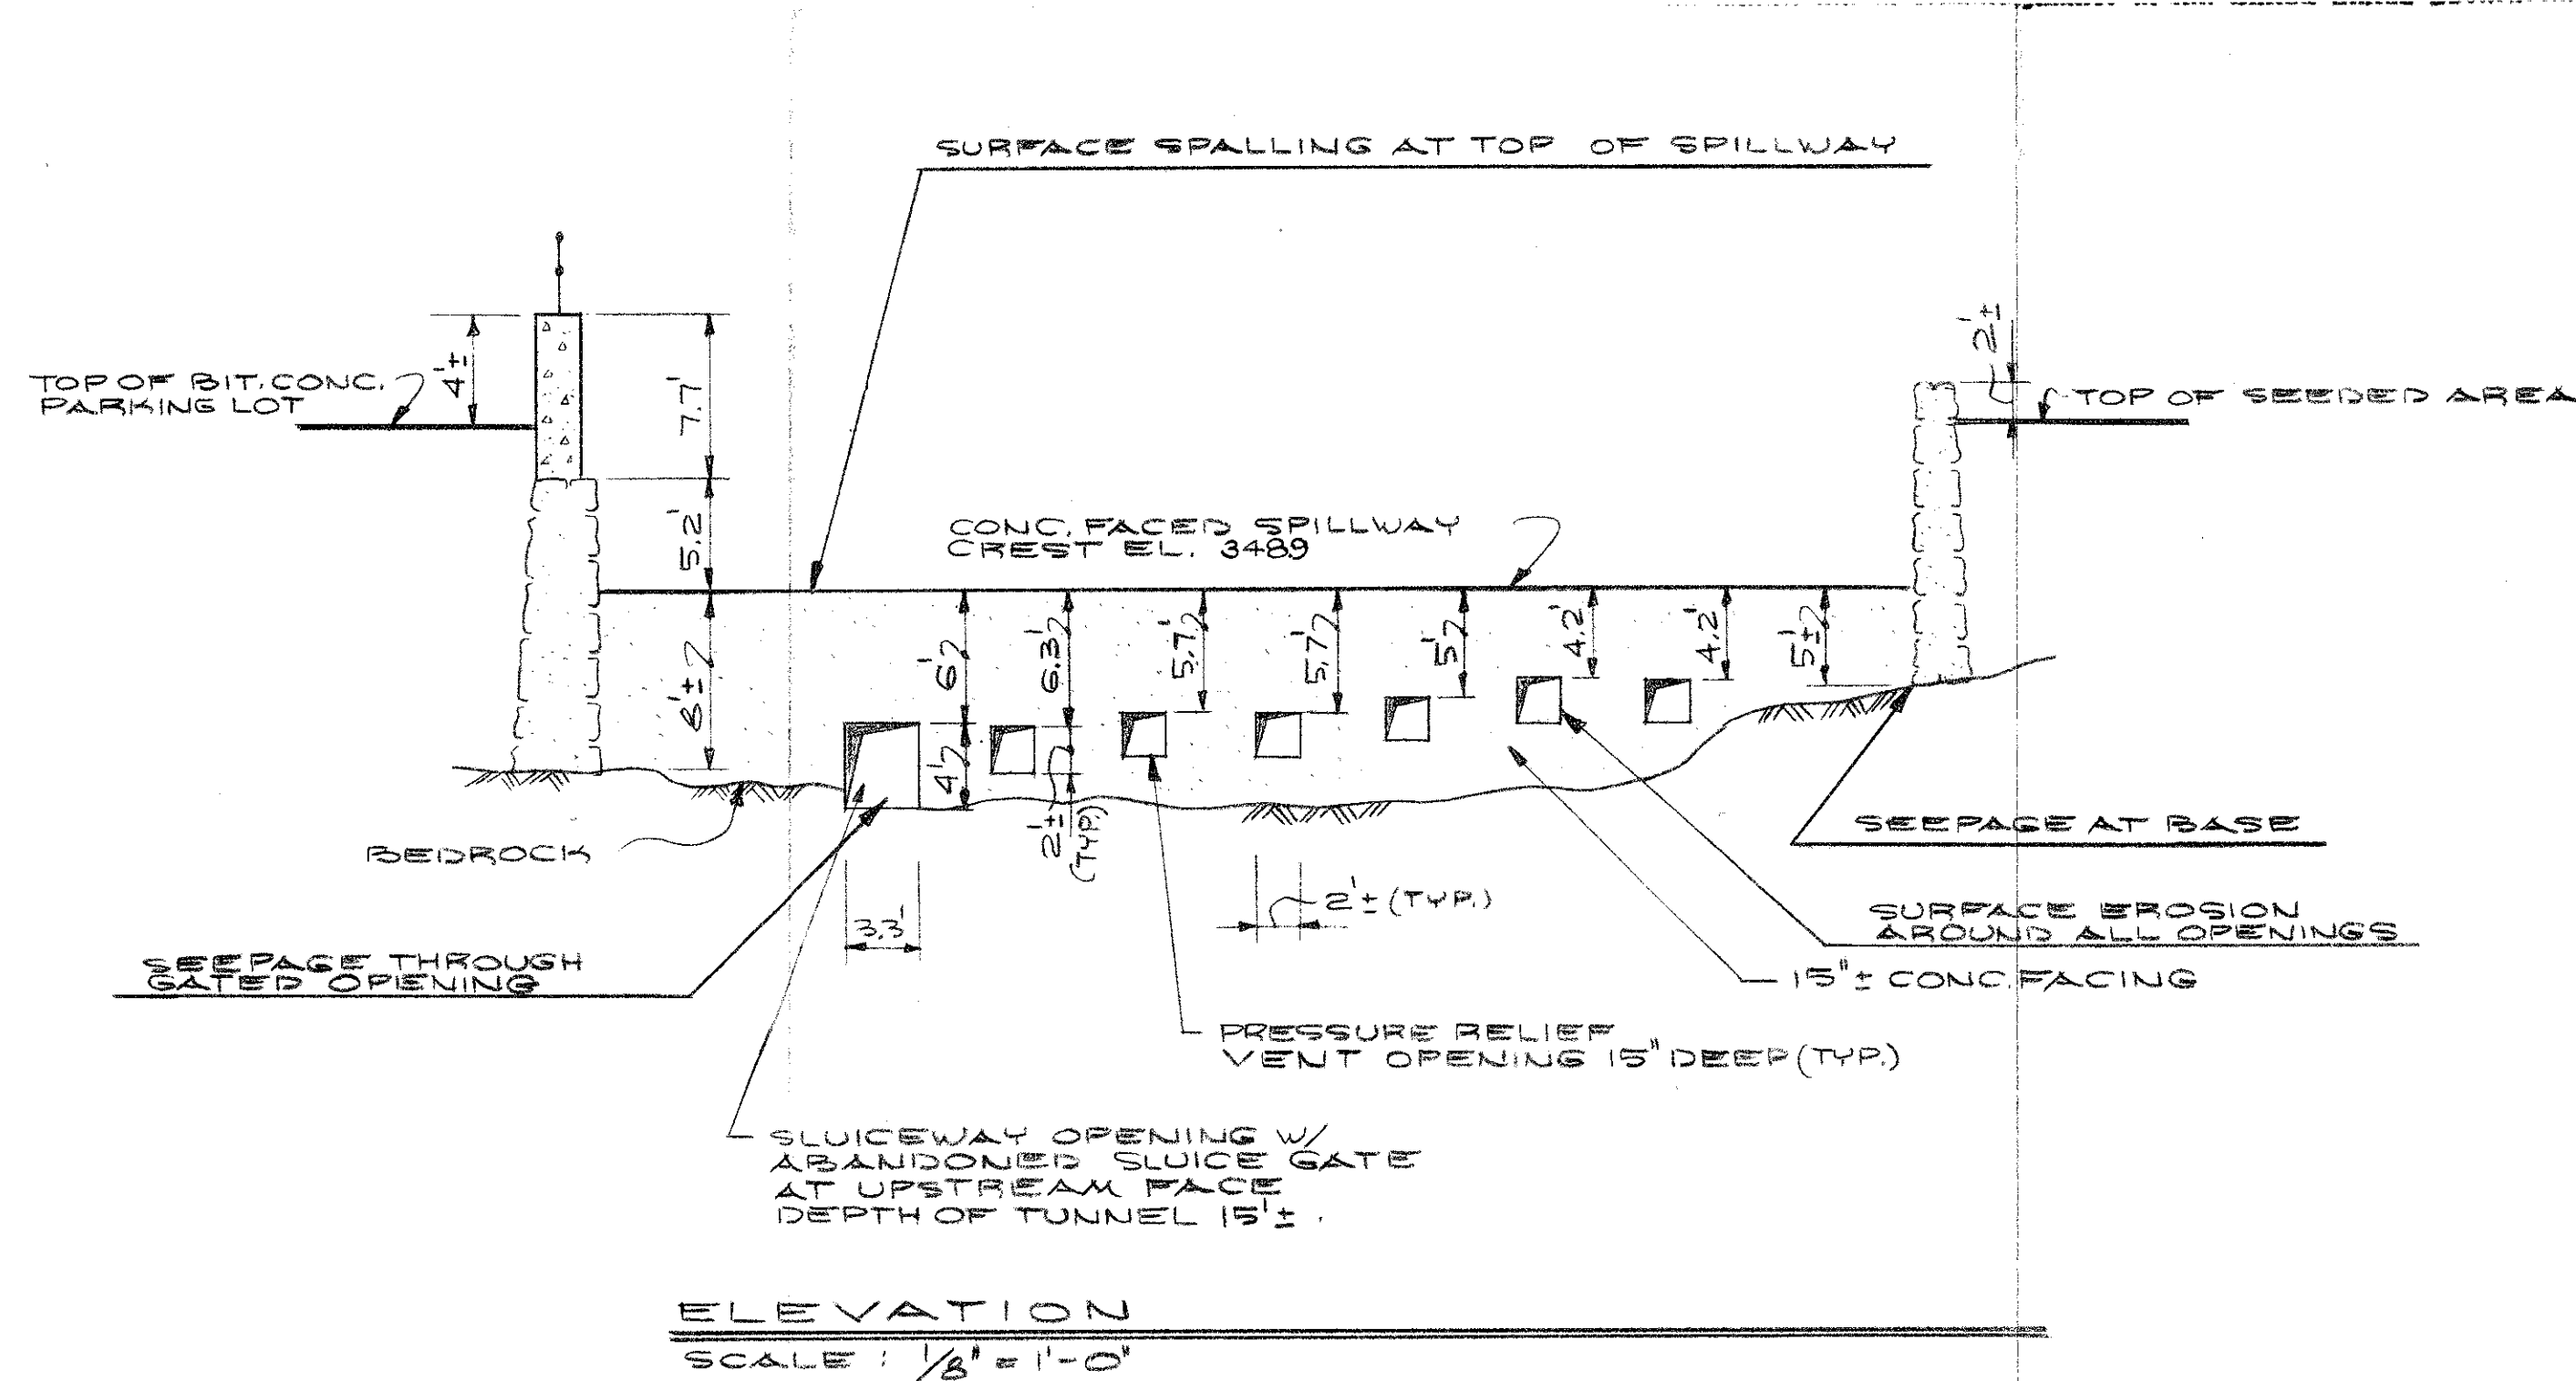
| FIGURE 2 | | | |

These structures are constructed with cemented stone masonry with a cemented squared stone masonry capstone approximately 18 inches wide. The total length of these walls is approximately 125 feet and are aligned approximately as shown on Figure 2 of Appendix B.

These structures consist of dry and cemented stone masonry with a concrete wall addition that is 7.7 feet high. The downstream masonry walls are cemented while the upstream walls are dry. The tops of the concrete walls are approximately 2 feet wide and support a pipe rail fence. The overall length of these walls is about 118 feet. The walls are laid out approximately as shown on Figure 2 of Appendix B.

(1) Left Training Walls (See Fig. 2 of Appendix B)

Seepage (Photo 2) of approximately 15 to 30 gpm was flowing through the interface of the stone and the rock foundation. Steel shear pins have been driven immediately downstream of the spillway to resist lateral movement of the base of the wall. Supplementary stone masonry was set in mortar in the vicinity of the downstream angle point in the wall. This masonry was placed in front of the original wall for approximately 15 feet. A prior failure had occurred at this location. Seepage at the rate of 2 to 4 gpm was flowing through a vertical joint between the downstream end of this wall and the bridge spandrel wall. The outlet for the seepage is approximately 1 foot below spillway crest elevation. Minor joint erosion was observed along the wall.
